# **PHASE II DEVELOPMENT OF A BULLNOSE GUARDRAIL SYSTEM FOR MEDIAN APPLICATIONS**

## **MIDWEST ROADSIDE SAFETY FACILITY**

MwRSF Research Report No. TRP-03-78-98

December 18, 1998

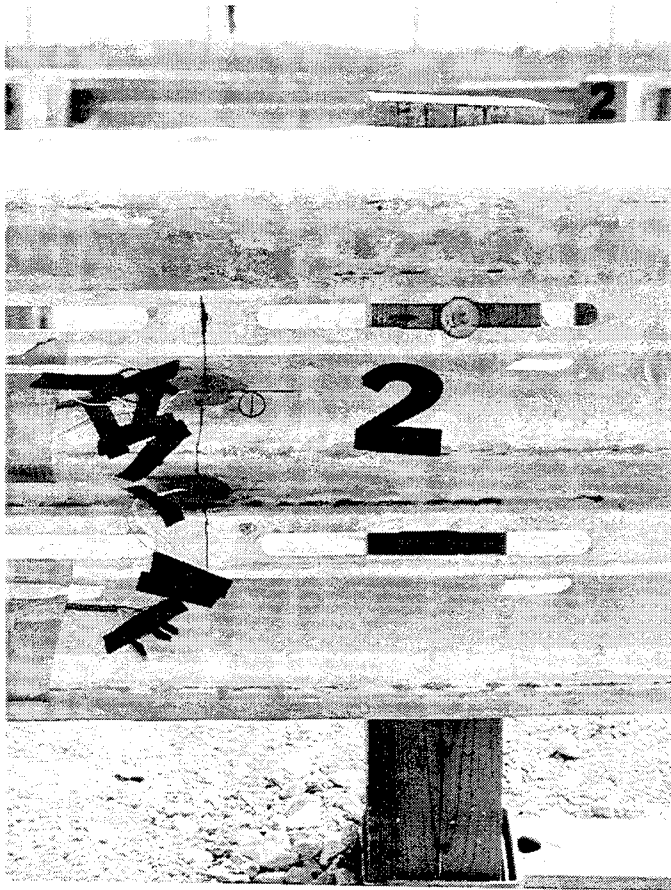
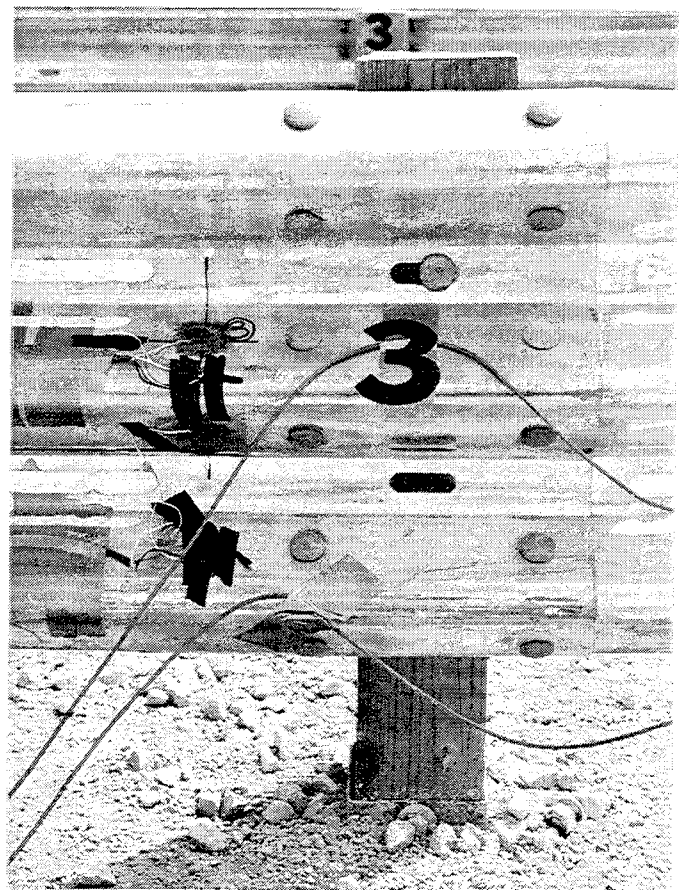
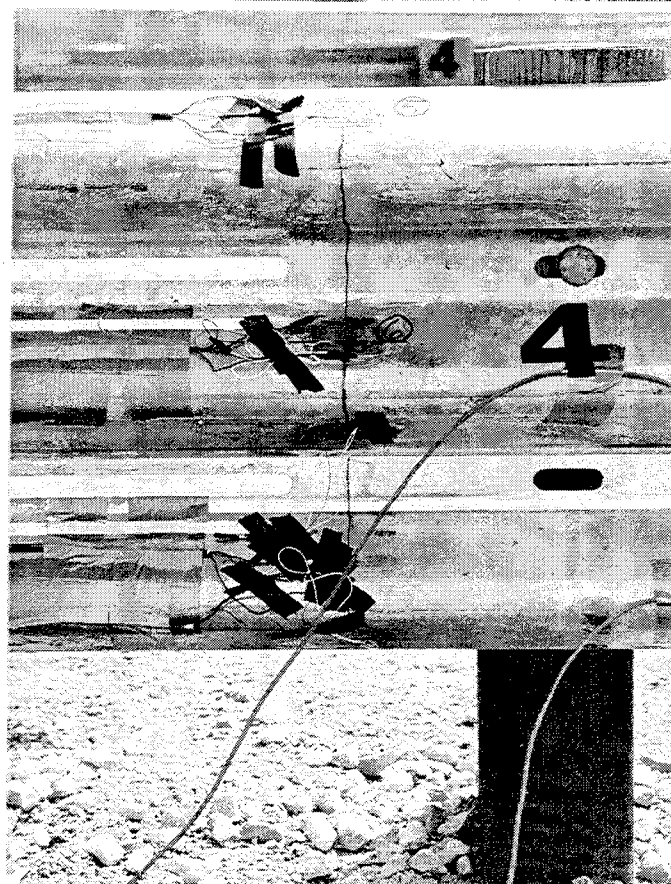
Figure 17. Strain Gauges for Full Scale Test MBN-3

For test MBN-3, a series of strain gauges were installed on the thrie beam guardrail that consisted of eight gauges located the front side of the thrie beam rail. The strain gauge positions are given in Table 3, and photographs showing the gauges on the bullnose barrier are shown in Figure 17. Strain gauges were not used in the instrumentation for the small car test, test MBN-4.

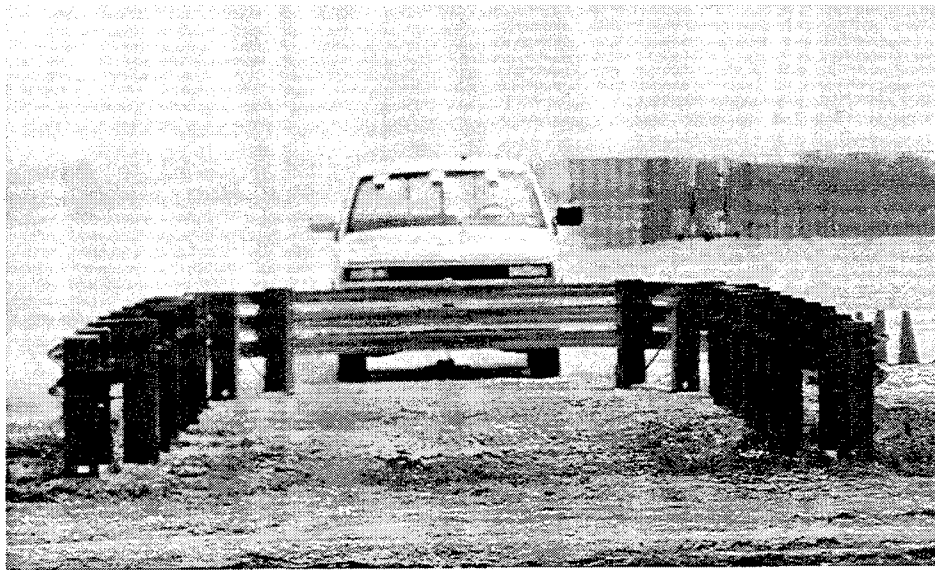
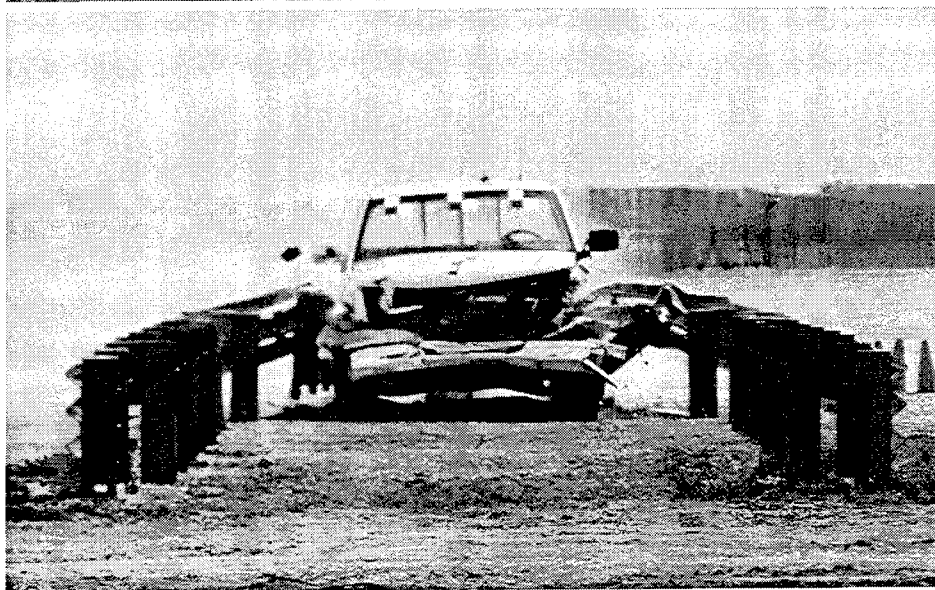
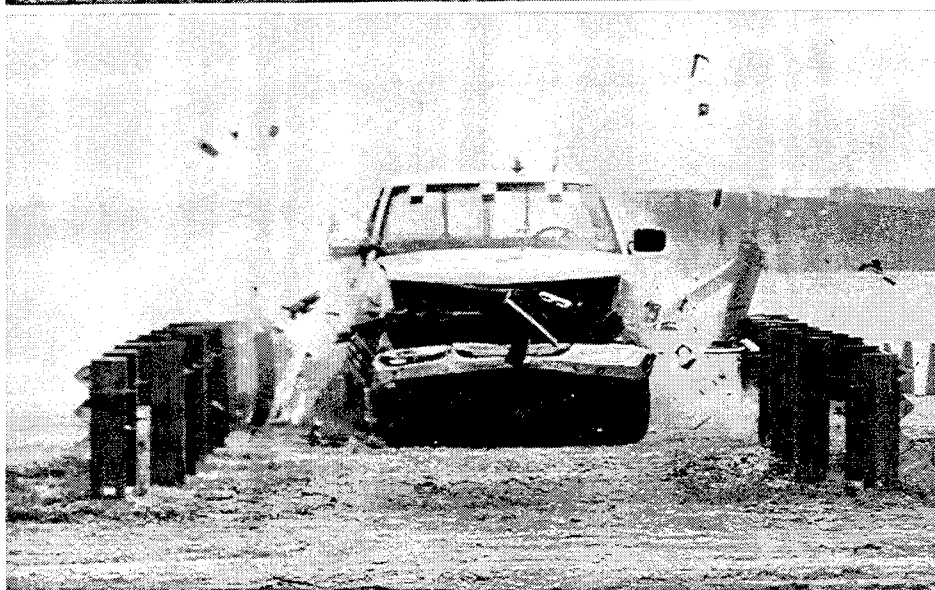
Figure 21. Full-Scale Crash Test MBN-3

The 1,989-kg pickup truck impacted the bullnose barrier at a speed of 100.16 km/h and an angle of -1.08 degrees. A summary of the test results and the sequential photographs are shown in Figure 19. Additional sequential photographs are shown in Figure 20. Full-scale crash documentary photographs are shown in Figures 21 and 22.

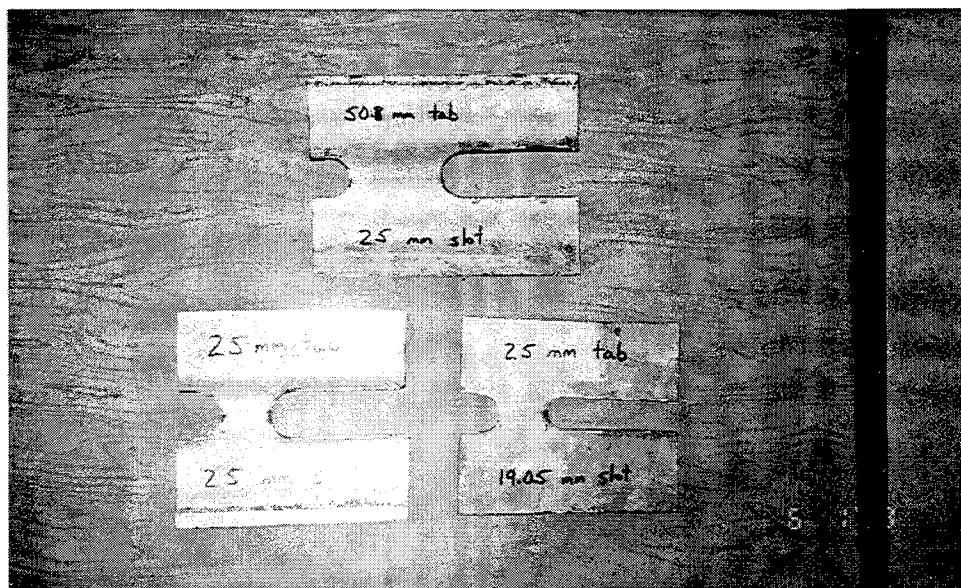
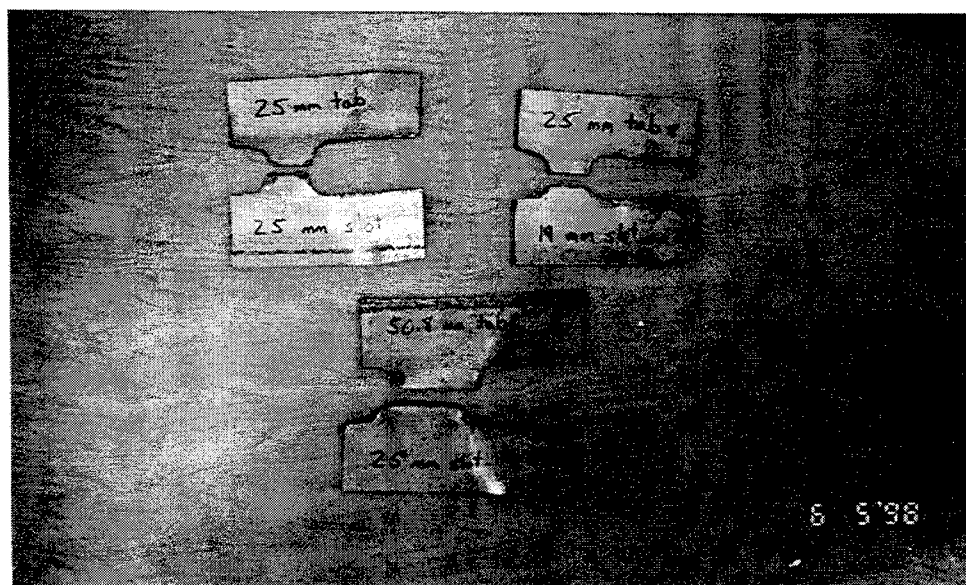
Figure 29. Physical Testing of Slot Tabs

Initial simulation of the model described above did not accurately simulate test MBN-3, because the guardrail material did not tear during the simulation. This required a more detailed investigation into material failure. A component test and corresponding component simulation were set-up to mimic the tab tearing between the slots in the center section of the rail. Two different tab sizes were investigated, one 25 mm in length and the other 50 mm in length. Using a Material Testing Systems (MTS) machine, the right ends of the samples were pulled apart until the tabs failed and the force levels were recorded. Four static component tests were completed with each tab size. Photographs of the slot tab testing are shown in Figure 29.

During component testing, the 25-mm length tab tore at an average maximum force of 23.7 kN, while the 50-mm tab tore at an average of 27.2 kN, resulting in approximately a 15 percent increase in strength. Computer simulation of the component testing, using an effective plastic strain

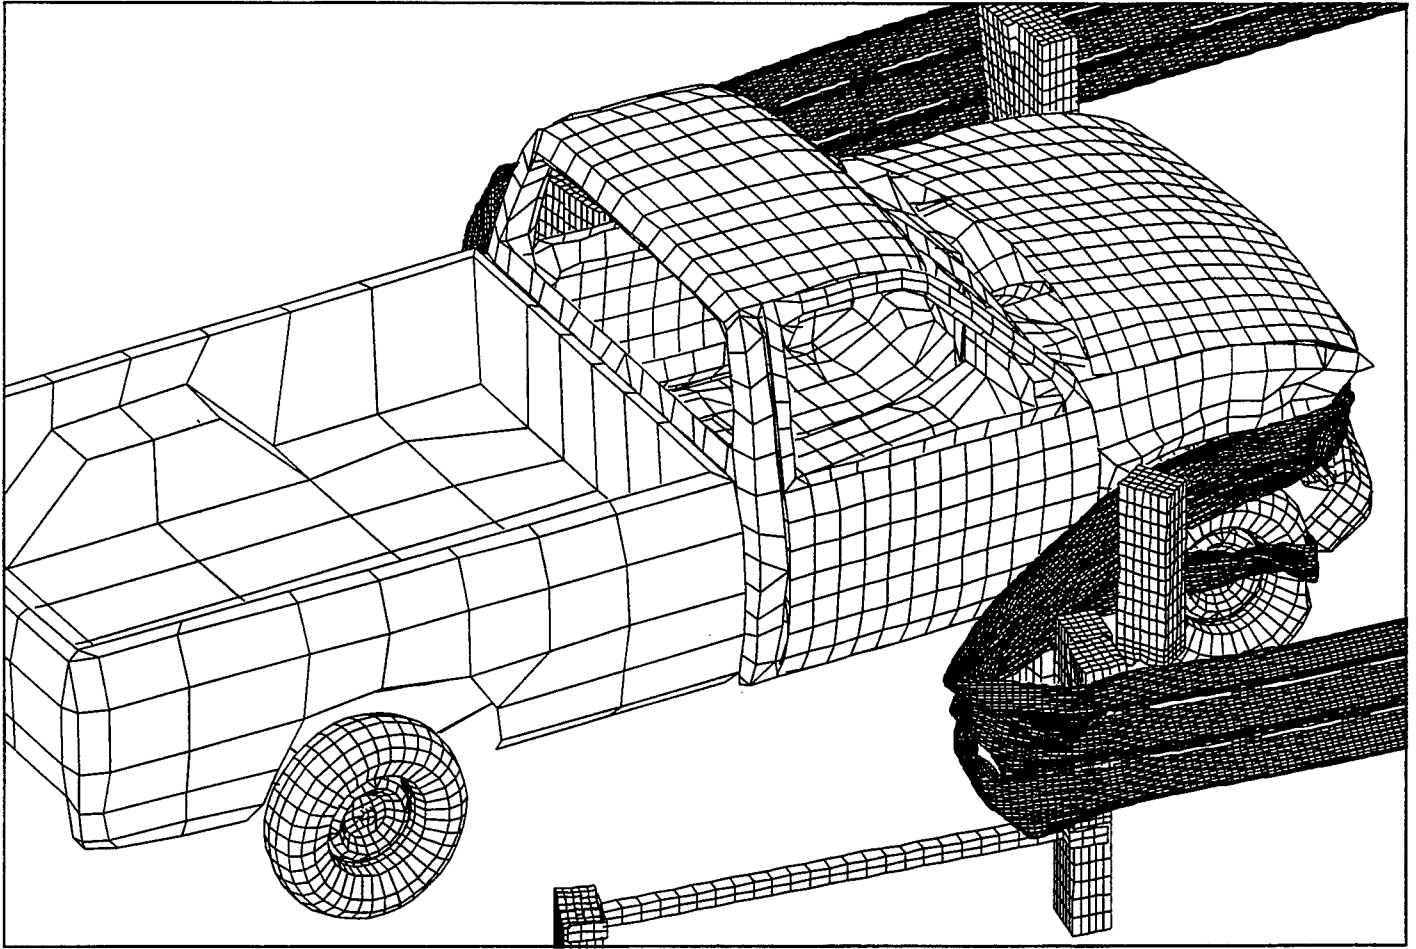
Figure 30. Lower Rail Catches on Tire

Using the material properties obtained from the component study and the refined rail mesh, the bullnose model was again simulated. This time, the tabs connecting the peaks of the thrie beam tore, allowing the rail to wrap around the front of the truck, as seen in Figure 30. However, as shown in Figure 30, the lower peak of the rail caught on the front tires. In the physical test, the rail was pushed down, and the front tires rolled over the lower rail section. It was thought that the difference between test and simulation results was due to the absence of a rotating tire in the model. Thus, capabilities for a rotating tire were added to the model.

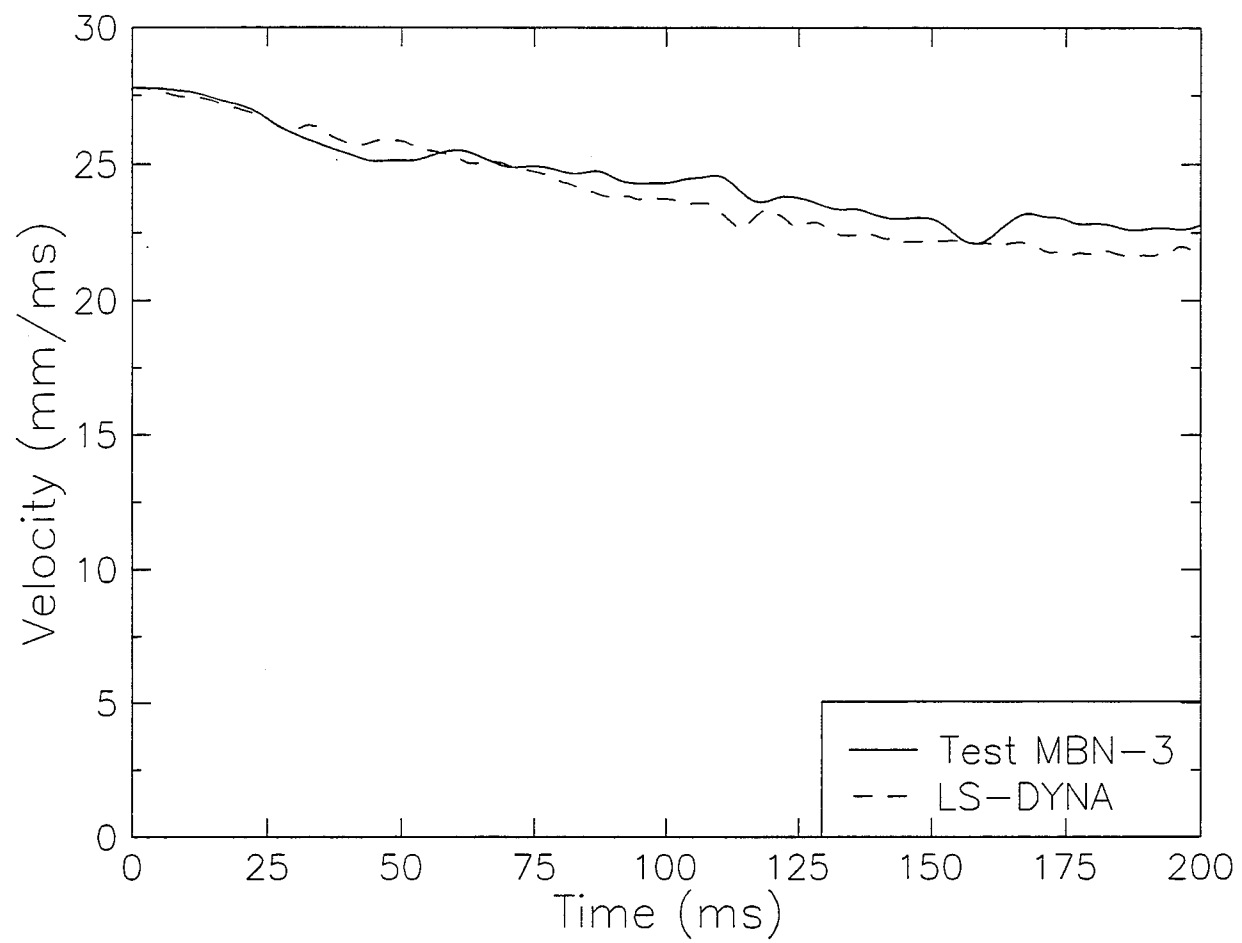
Figure 33. Velocity Comparison for MBN-3

With material failure and rotating tires defined, simulation of test MBN3 was repeated. This time the results were very encouraging, as shown in Figures 32 and 33. As the truck impacted the rail, the three peaks separated, wrapping themselves around the front of the truck. The lower peak contacted the tires and was pushed down and driven over by the front tires. As the rail wrapped around post no. 1, the upper two peaks of the rail tore just before the first splice in the rail. The vehicle then proceeded to penetrate behind the bullnose system. The velocity comparison between test and simulation is shown in Figure 33. After 200 ms, the vehicle was essentially rolling unconstrained and thus, not of concern.
